## Dust cloud ignition caused by static electricity.

Mike O'Brien, Managing Director, Newson Gale.

**Newson Gale's latest series of articles that contain case studies of fires and explosions caused by static electricity draw attention to the wide range of processes that are susceptible to electrostatic charge generation and accumulation on portable and fixed plant equipment.**

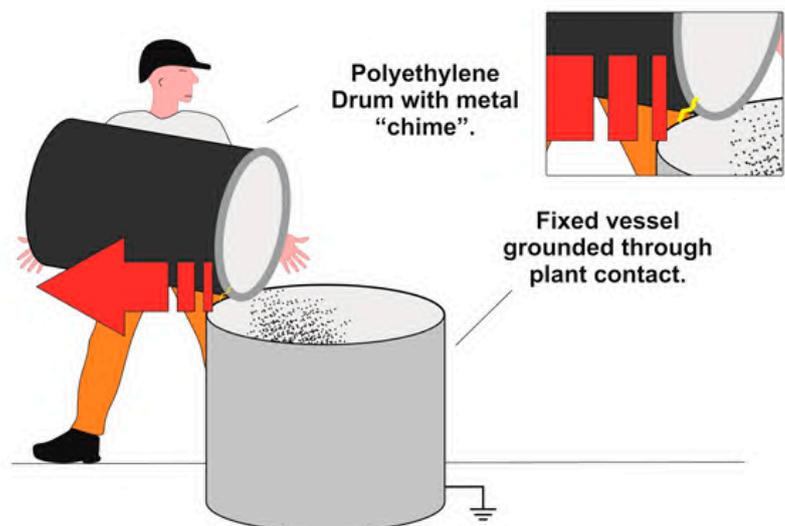
This case study investigates the factors behind the ignition of a combustible dust cloud during a manual powder processing operation. In this example a process operator was tasked with manually tipping approximately 18 kg (40 lbs) of powder from a plastic drum, constructed from polyethylene, into a metal process vessel. The plastic drum contained a combustible powder that had a minimum ignition energy of 12 milli-joules. A metal chime was positioned around the circumference of the top of the plastic drum to provide it with impact protection from daily usage in the plant.

The operator tipped the powder into the process vessel, resting the drum on the edge of the vessel. As he removed the drum from the vessel when the powder was fully deposited there was an ignition of the dust cloud that had formed at the top of the vessel.

It was postulated that the accumulation of electrostatic charge on the chime resulted in a static spark discharge from the chime as it came into close proximity with the vessel when the drum was removed. The vessel was grounded through its own fixed connection to the plant.

In order to verify this theory an experiment was conducted to determine how much electrostatic charge could have been generated by the movement of the powder. 18 kg (40 lbs) of the same powder was tipped from a similar drum into a Faraday cage from which electrostatic charge measurements were taken.

A charge of 3.6 micro-coulombs was measured on the Faraday cage which received the powder. In this case the powder was charged due to the friction caused between the powder and the plastic drum as the powder slid down the inside surface of the drum. A field meter reading of 500 KV/m (the maximum voltage the meter was capable of measuring) was recorded on an isolated area of the plastic drum which would have had the effect of charging the metal chime by induction.

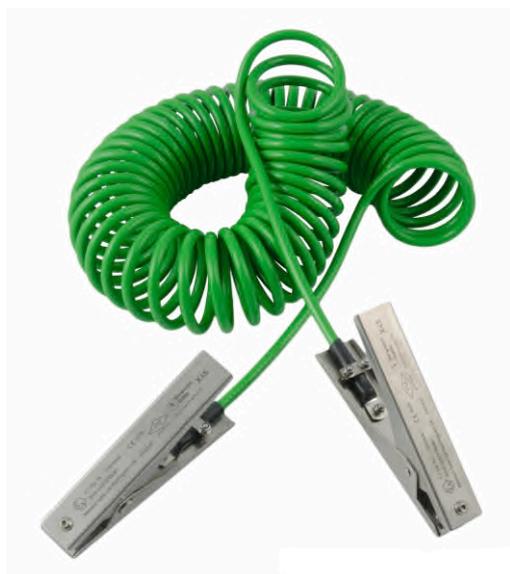
VESX45 – dual clamp assembly for connecting portable objects

Devices like the ones highlighted in the pictures below can be used to connect the drum to the grounded process vessel. At minimum a grounding clamp with FM/ATEX approvals, like the example in the picture on the left, should be specified so that any physical impedances like paint coatings and product deposits are fully penetrated to make contact with the base metal. The picture on the right shows a device that will inform the operator when he/she has achieved a connection resistance of 10 ohms or less between a metal drum and the process vessel. This is indicated via a pulsing green LED mounted in the grounding clamp that provides the operator with a simple GO / NO GO instruction to tip the powder into the process vessel.

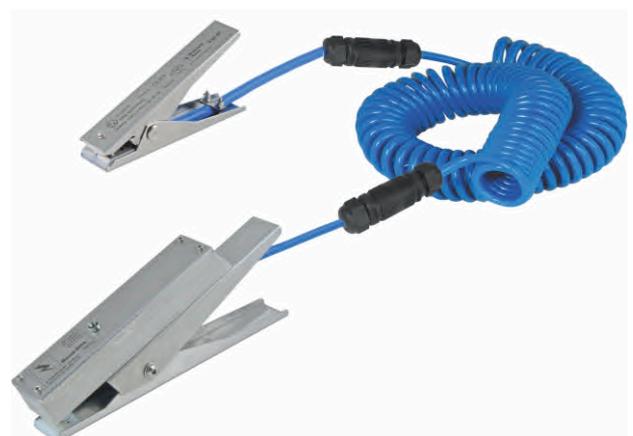
Bond-Rite® EZ with clamp mounted LED indicator that pulses green when a connection resistance of 10 ohms or less is made between conductive portable equipment.
