Spark from isolated hose ignites combustible powder atmosphere

Static electricity is often perceived as an invisible risk. This case study explains why static electricity provides an ignition source for serious fires and explosions that could occur during everyday operations involving the handling and processing of flammable products.

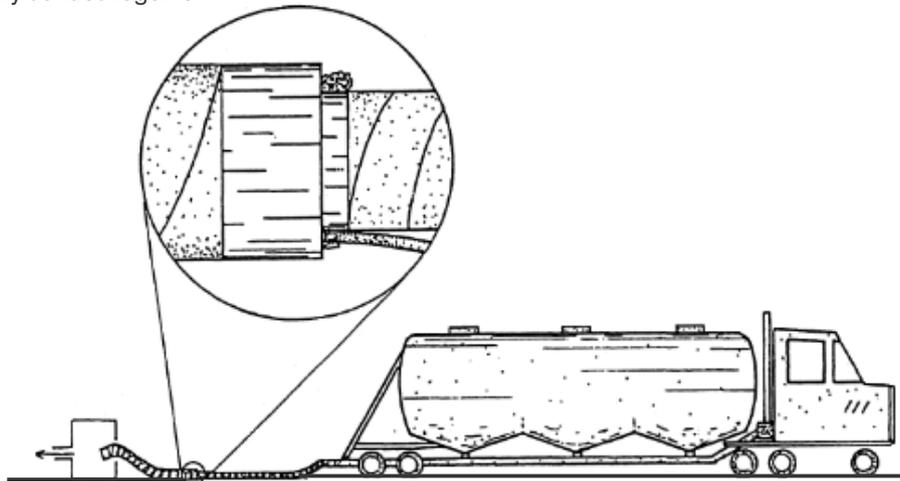
The truck was grounded so the 3" hoses (assuming they were in good condition) were also grounded, hence the risk of an accumulation of electrostatic charge on the truck and hoses was minimal. One issue that was encountered, however, was that the plant hose that was used to complete the distance between the truck's hoses and the entry to the plant's pneumatic system was wider in diameter to the truck's hoses. This meant that a sealed connection between the hoses could not be made. The operators overcame this issue by stuffing rags into the gap between the hose flanges. This had the effect of electrically isolating the plant hose from the truck's hose, potentially impeding the transfer of electrostatic charges from the plant hose to ground via the grounded truck. The other end of the hose was assumed to have been resting on the concrete floor inside the plant. The other issue was that the density of the air-powder phase coming from the truck was above the minimum explosive concentration of the aluminium powder.

Spark from isolated hose ignites combustible powder atmosphere

The isolated hose was estimated to have a capacitance of 30 pico-farads and a modest value for the streaming current generated by the transfer of the powder aluminium was estimated to be in the region of 10 micro-amperes. The resistance to ground of the isolated hose's flange, resting on the concrete floor, fell into a range of between 10^{10} ohms and 10^9 ohms. The voltage ($V=RI$) on the isolated hose, based on the upper and lower limits of resistance, was estimated to fall between 100 kilo-volts and 10 kilo-volts.

The energy, W , from a spark discharge based on the capacitance and voltage on the isolated hose ($W = 0.5 CV^2$), would have been in the range of 150 milli-joules to 1.5 milli-joules. Hence a spark from the isolated hose would have been likely to have had the capability to ignite an explosible concentration of the aluminium dust.

As the operators needed to improvise through this non-standard scenario, it is all too easy to criticise the lack of static grounding precautions that were adhered to. Electrostatic hazards are not an easy concept to grasp, especially when improvisation is required. One standard operating procedure that may have re-enforced good practice was to have the truck driver trained to test the electrical continuity of the hoses back to the grounded truck. This would enable the driver to ensure a transfer could not take place unless all components in contact with the charged powder were grounded. One means of achieving this is for the driver to carry out a resistance check with an ATEX/HAZLOC certified ohmmeter (or multi-meter) to ensure the combined resistance of the hoses does not exceed unsafe levels.

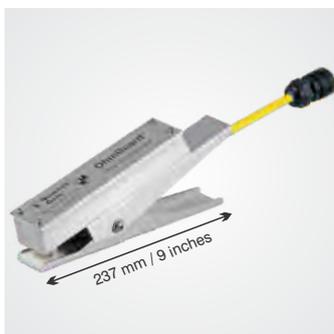
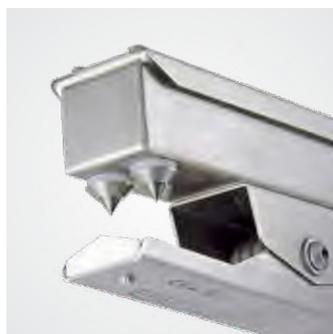
If there are concerns about the correct use of the meter an even simpler method is to utilize a device like an ATEX/HAZLOC certified OhmGuard® tester which provides the driver/operator with a visual indication of whether or not the hoses assembled together exceed safe resistance levels. By simply attaching one end of the OhmGuard to the truck and the other end, which houses the LED indicator, to the end of the interconnected hoses, the tester will automatically determine if the resistance through the hoses is higher than recommended levels. Following a "GO/NO GO" principle of operation, the pulsing green LED indicator visually confirms that the resistance of the interconnected hoses is low enough to dissipate electrostatic charge from the hose, preventing ignitable sparks being discharged into combustible atmospheres.
